**CALSPAN ON-SITE AIR BAG DEPLOYMENT INVESTIGATION**

**CALSPAN CASE NO. 93-9**

**VEHICLE #1 - 1990 FORD TAURUS GL (AIR BAG-EQUIPPED)**

**VEHICLE #2 - 1974 CADILLAC COUPE DEVILLE**

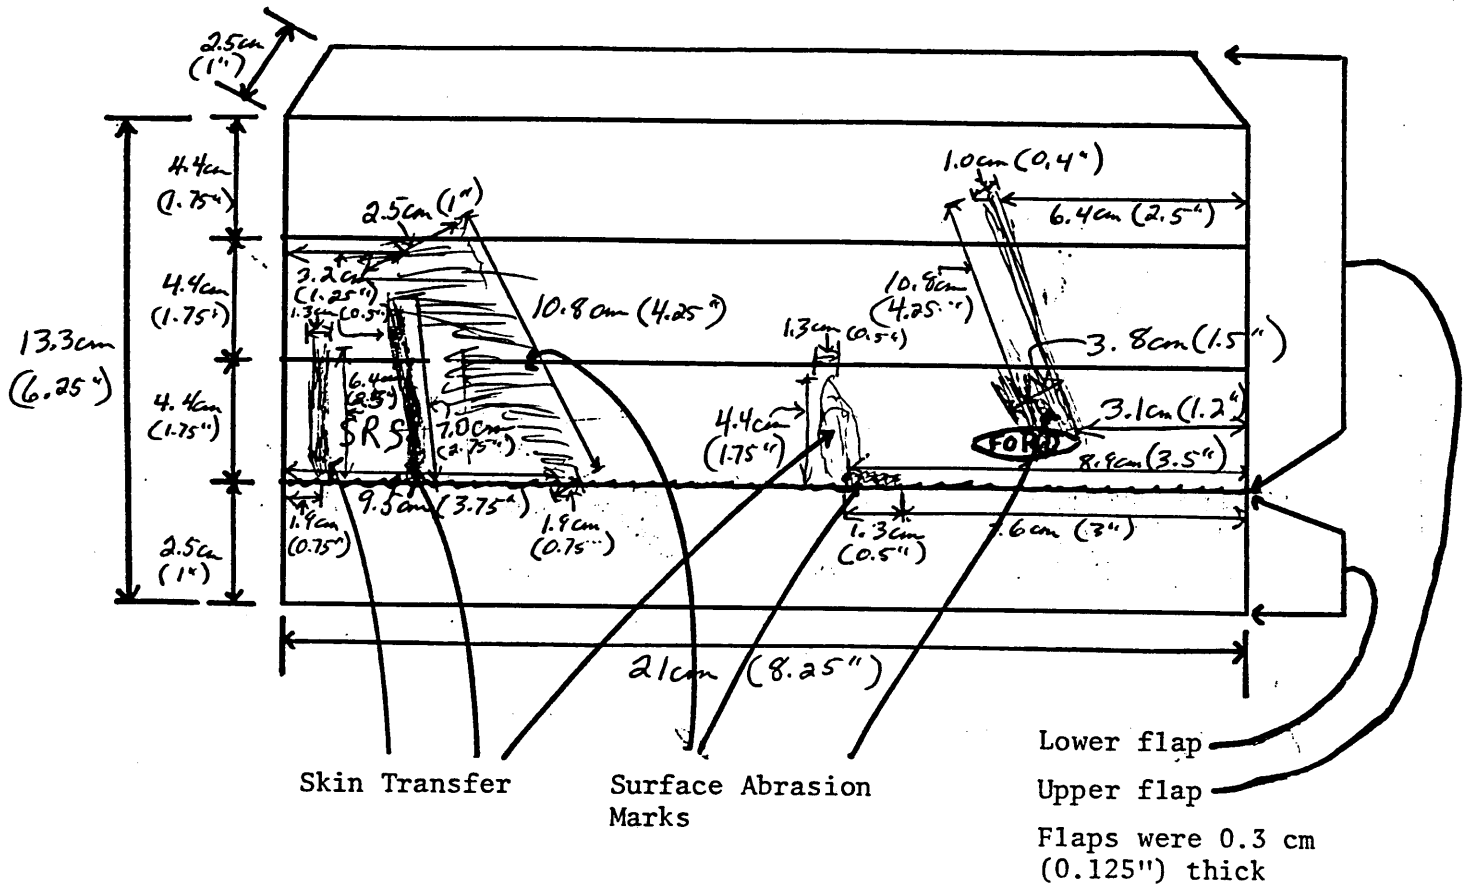
Vehicle #1 - Air Bag Module Cover

The upper flap of the air bag module cover exhibited abraded surface damage which was attributed to the interaction with the driver's necklace during the air bag deployment sequence. For documentation purposes, the abraded surface damage was divided into three areas. The largest and most visible area began along the bottom edge of the upper flap at 9.5 cm (3.75") right of the left corner and extended 10.8 cm (4.25") diagonally upward to the left, ending 3.2 cm (1.25") from the left side edge of the flap.

There were three skin transfer marks noted on the upper air bag module flap which were attributed to contact with the driver's neck during the air bag deployment sequence. The first was 1.3 cm (0.5") wide and began 1.9 cm (0.75") right of the left flap corner along the horizontal seam edge. This transfer extended vertically 6.4 cm (2.5"). The second transfer was also 1.3 cm (0.5") wide and began 4.8 cm (1.9") right of the left flap corner along the horizontal seam edge. This transfer extended vertically 7.0 cm (2.75"). The third transfer began 8.9 cm (3.5") left of the right corner along the bottom edge of the flap and ended 4.4 cm (1.75") above the seam line. This transfer was 1.3 cm (0.5") wide and less visible than the other skin transfer marks.

There were three skin transfer marks noted on the upper air bag module flap attributed to contact with the driver's neck during the air bag deployment sequence. The first was 1.3 cm (0.5") wide and began 1.9 cm (0.75") right of the left flap corner along the horizontal seam edge. This transfer extended vertically 6.4 cm (2.5"). The second transfer was also 1.3 cm (0.5") wide and began 4.8 cm (1.9") right of the left flap corner along the horizontal seam edge. This transfer extended vertically 7.0 cm (2.75"). The third transfer began 8.9 cm (3.5") left of the right corner along the bottom edge of the flap and ended 4.4 cm (1.75") above the seam line. This transfer was 1.3 cm (0.5") wide and less visible than the other skin transfer marks.

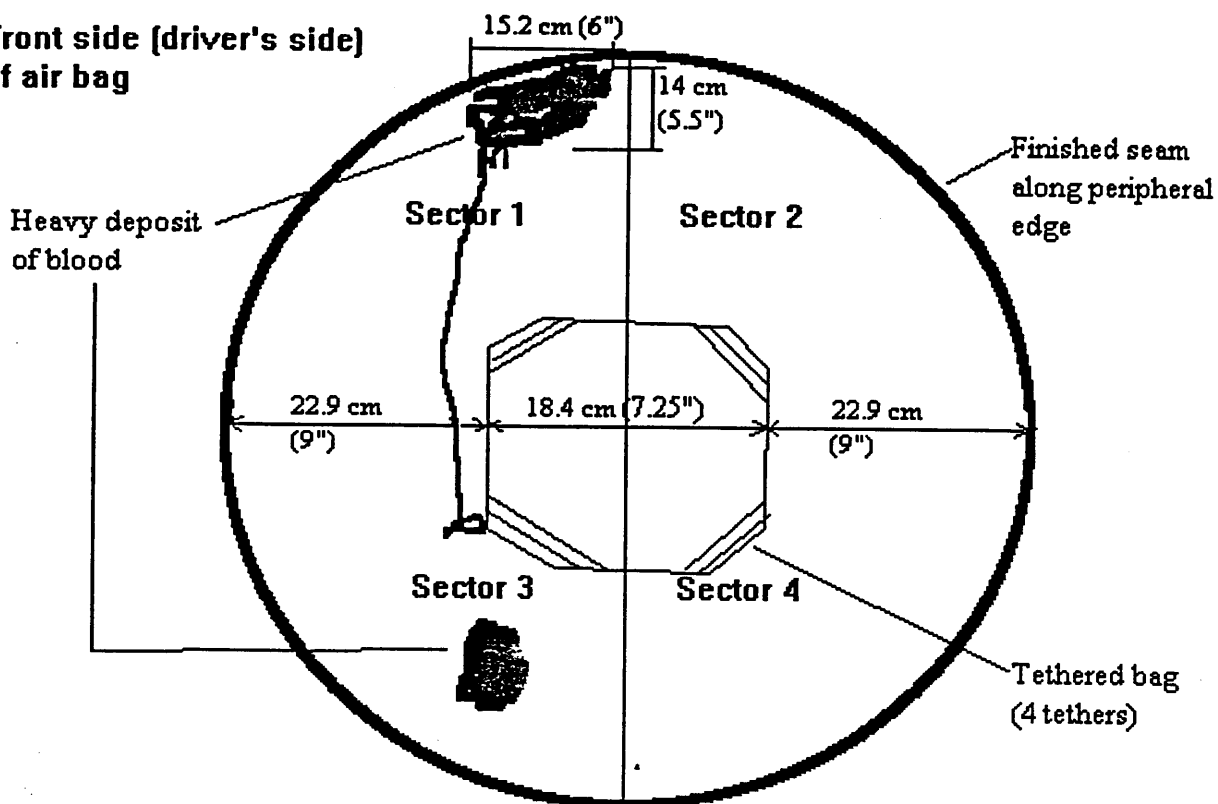
**Front side (driver's side)  
of air bag**

A red lipstick transfer was noted on the instrument panel side of the air bag along the top peripheral seam line left of the center line. Blood deposits from the driver were noted in the upper left and lower left quadrants (Sectors 1 and 3).

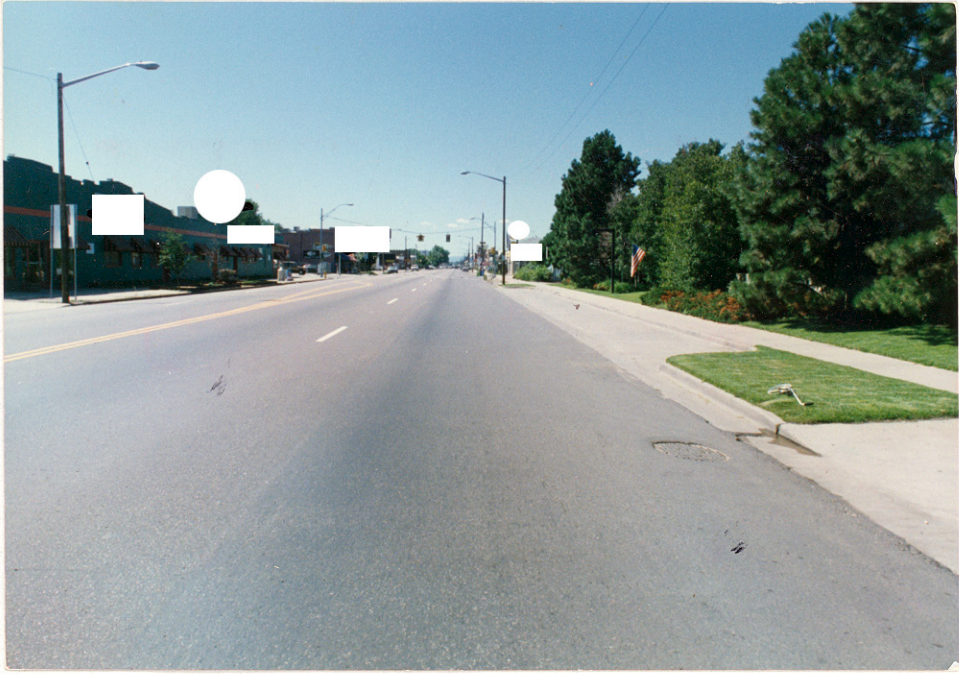
1. Trajectory of the 1990 Ford Taurus GL (Vehicle #1) approximately 45 m (150') prior to point of impact (POI) with the Cadillac DeVille (Vehicle #2)

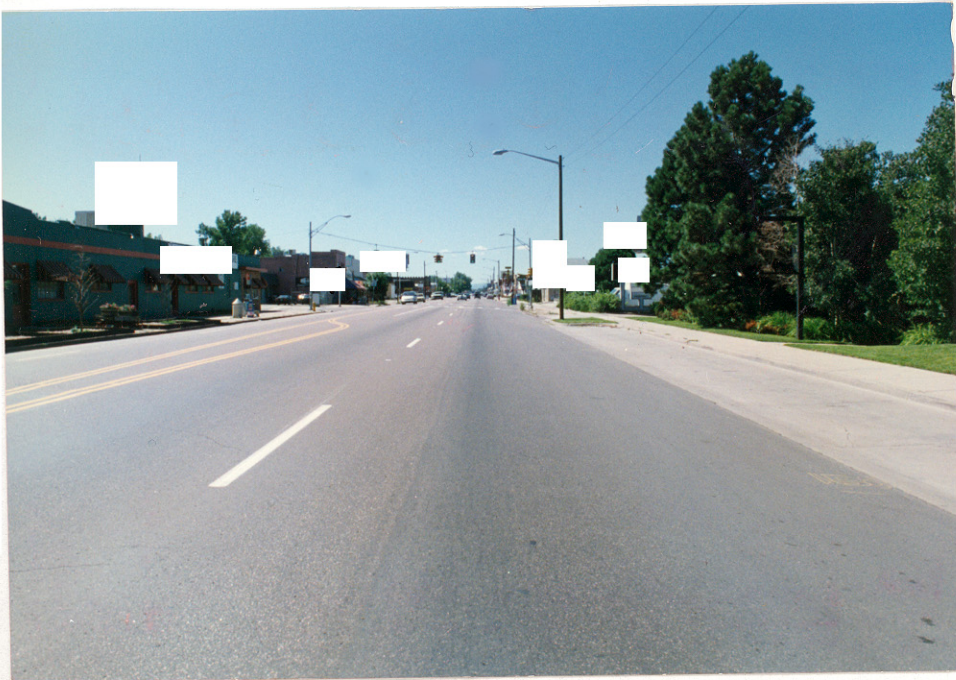
2. Trajectory of Vehicle #1 approximately 30 m (100') prior to the POI

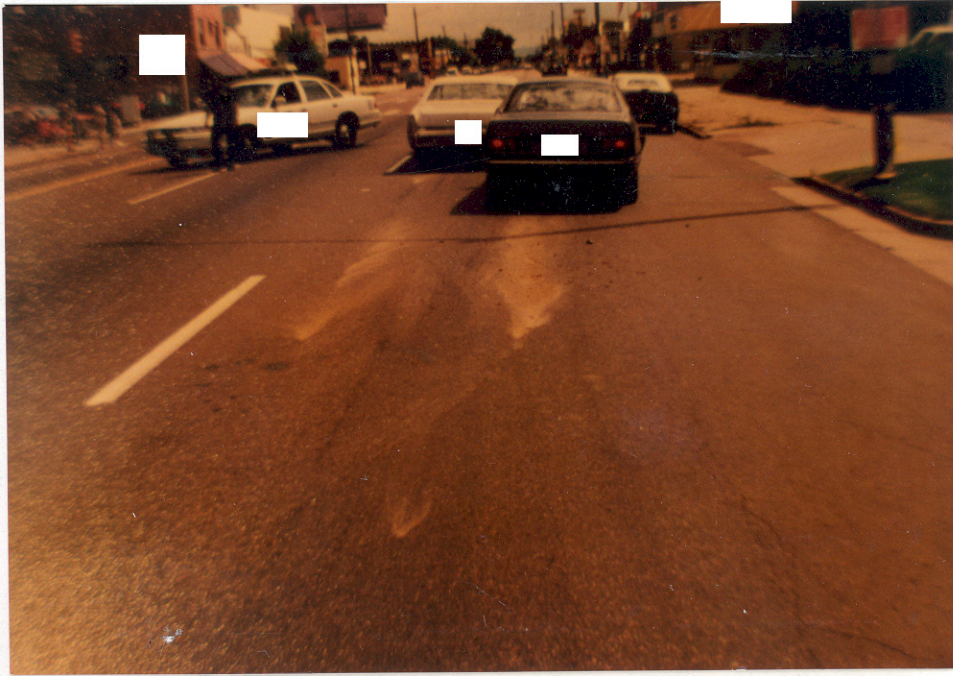
5. On-scene police photograph showing dirt debris from the undercarriage of Vehicle #2 at POI and post impact trajectory

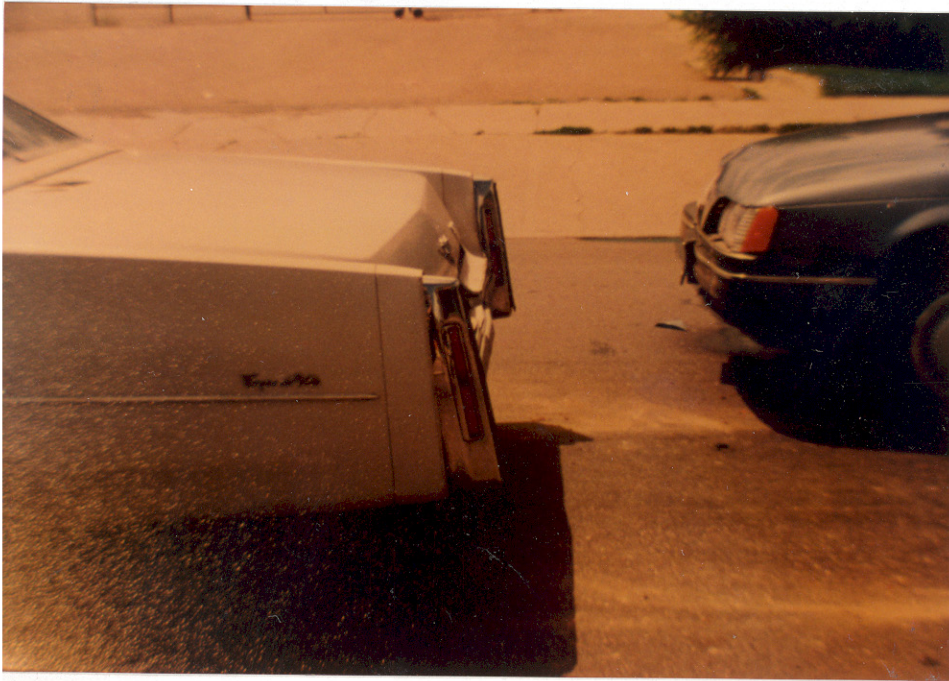
9. Lateral (westerly) view of both vehicles at FRP showing the distance of separation between the rear bumper of Vehicle #2 and the front bumper of Vehicle #1 [1.0 m (3.3')]

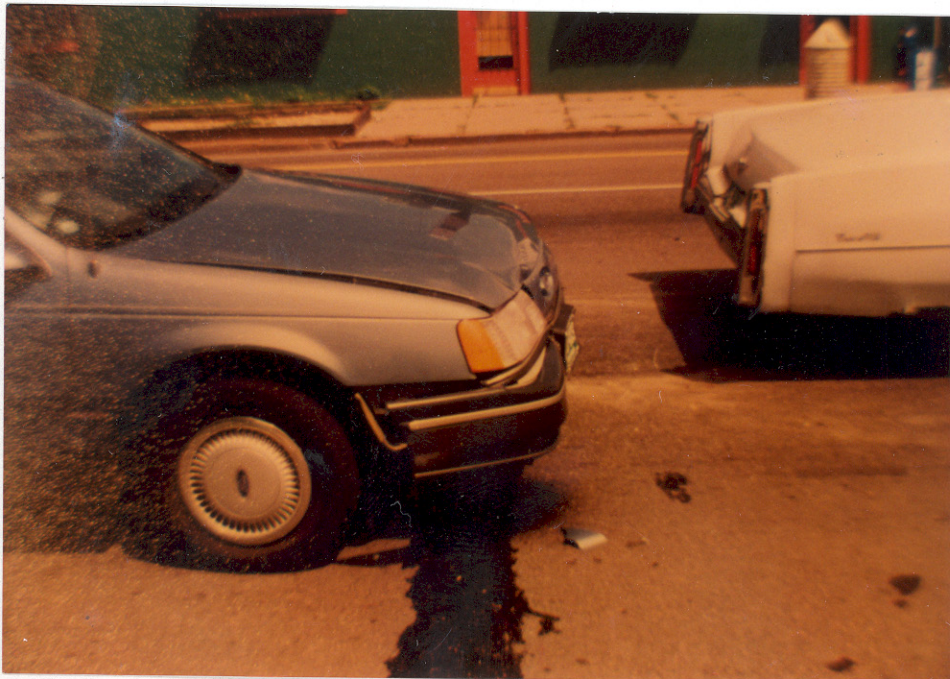
10. Lateral (easterly) view of both vehicles at FRP, highlighting the radiator spill and right front tire steer angle of Vehicle #1

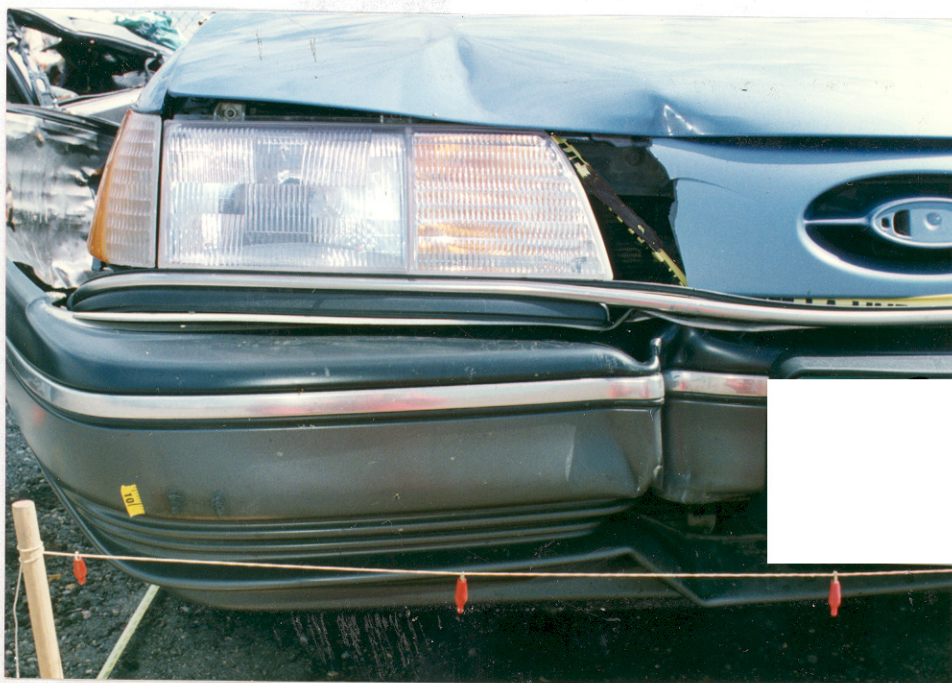
14. Close-up view of the front right section of Vehicle #1, highlighting the damage pattern on the bumper and grille panel consistent with the vertical design of Vehicle #2's right rear taillight

14.	Close-up view of the front right section of Vehicle #1, highlighting the damage pattern on the bumper and grille panel consistent with the vertical design of Vehicle #2's right rear taillight assembly

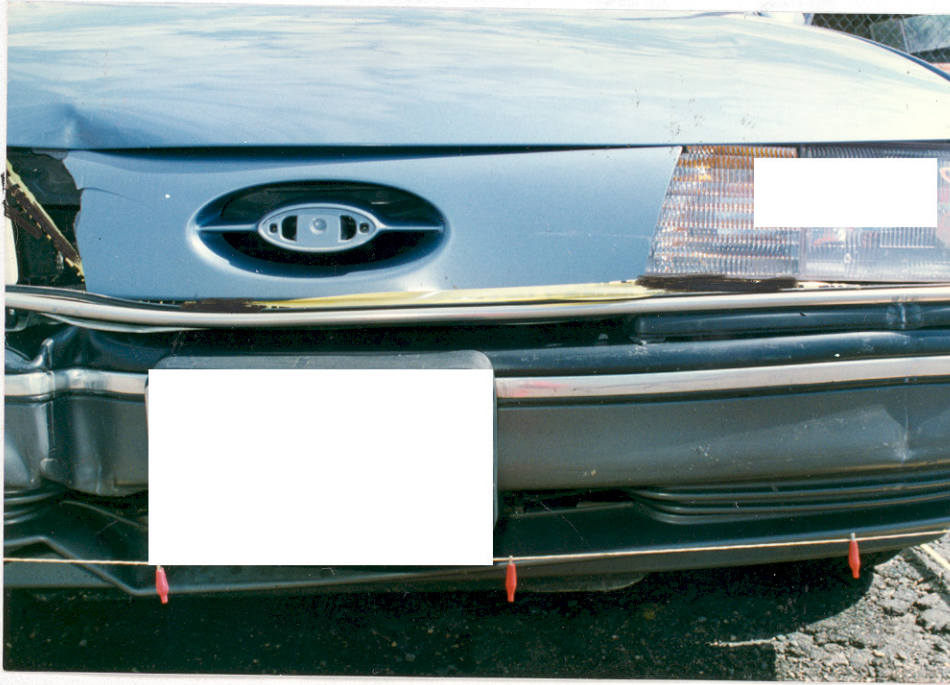
15. Close-up view of the front center section of Vehicle #1, highlighting damage along a mid line on the license plate which aligned with contact on Vehicle #2's rear bumper rub strip

15.	Close-up view of the front center section of Vehicle #1, highlighting damage along a mid line on the license plate consistent with contact on Vehicle #2's rear bumper rub strip

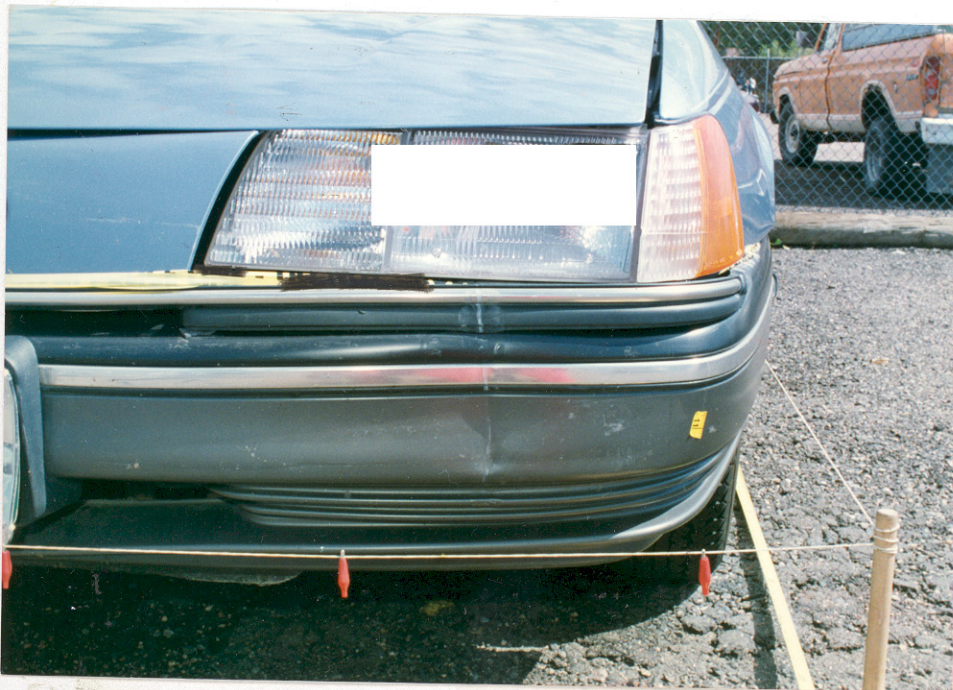
16. Close-up view of the front left section of Vehicle #1, highlighting contact damage on the bumper surface consistent in shape with the vertical right rear taillight assembly of Vehicle #2

16.	Close-up view of the front left section of Vehicle #1, highlighting contact damage on the bumper surface consistent in shape with the vertical right rear taillight assembly of Vehicle #2

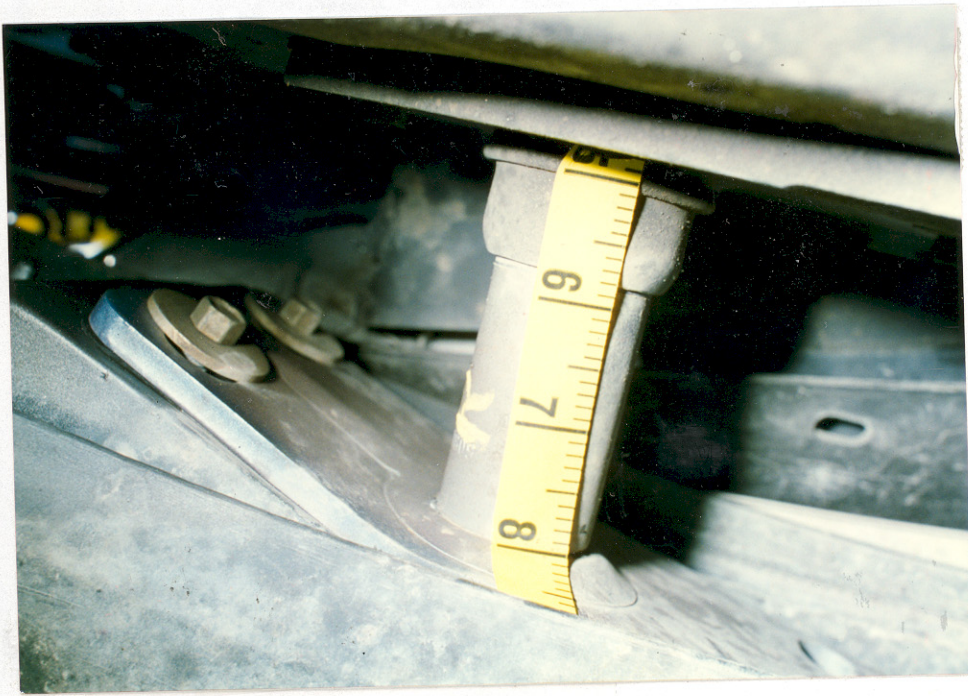
17. Right front bumper energy absorption device (EAD) of Vehicle #1 showing 0.3 cm (0.1") of compression with full restitution

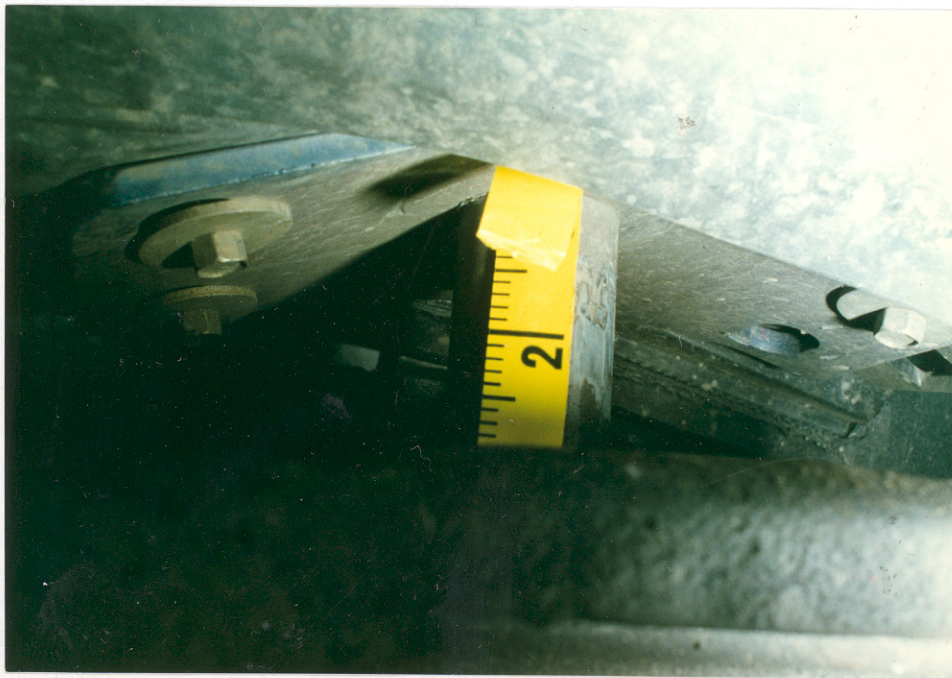
18. Left front bumper EAD showing 4.8 cm (1.9") of compression with full restitution

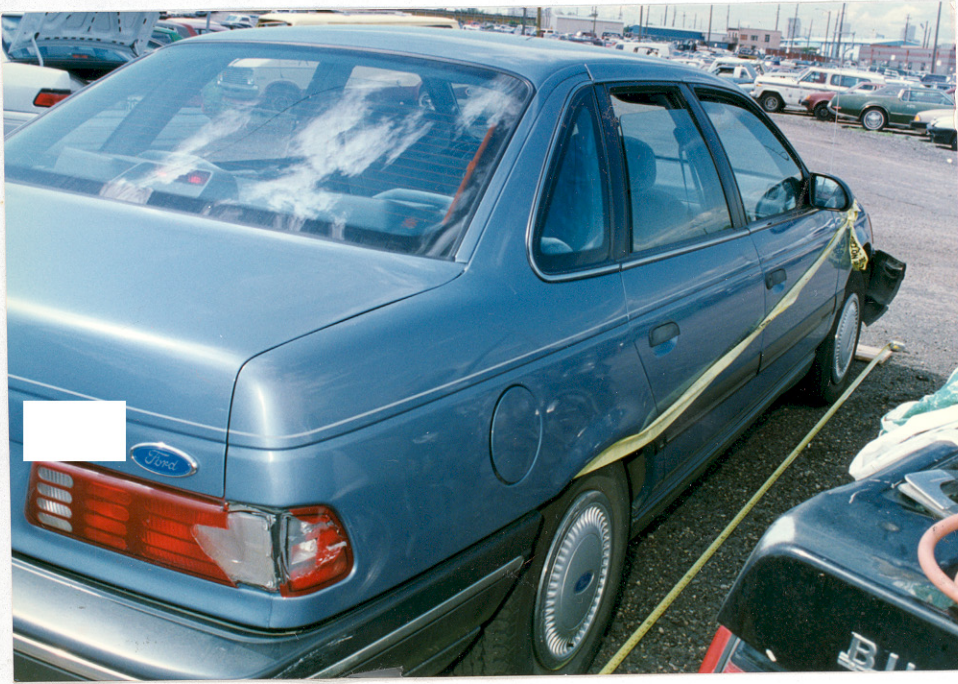
25. Right rear corner view showing broken taillight lens assembly (damage not related to crash)

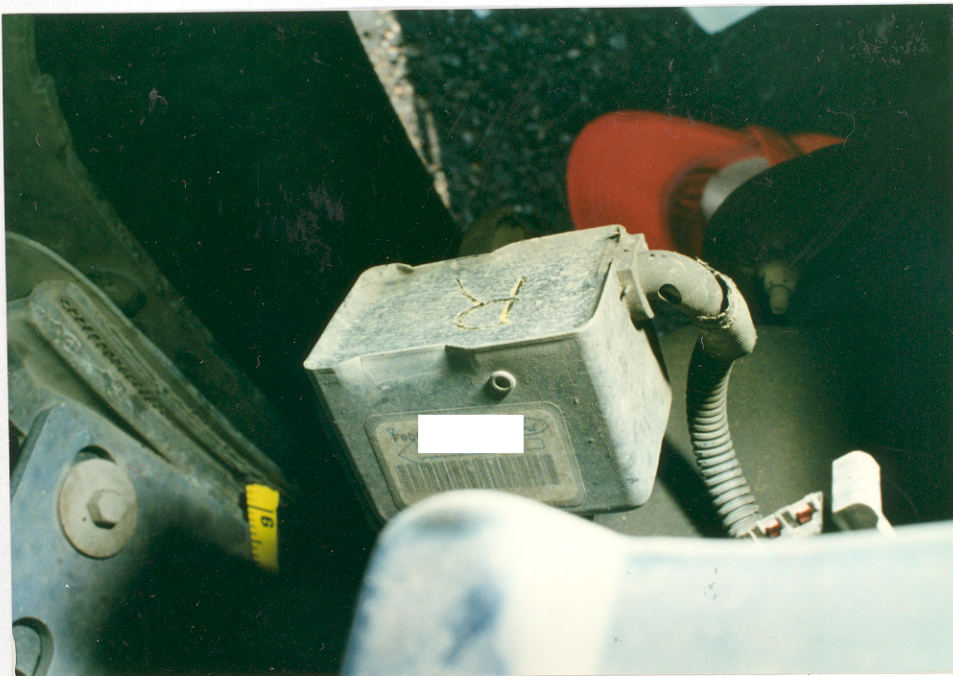
28. Lateral overhead view of the right front air bag crash sensor

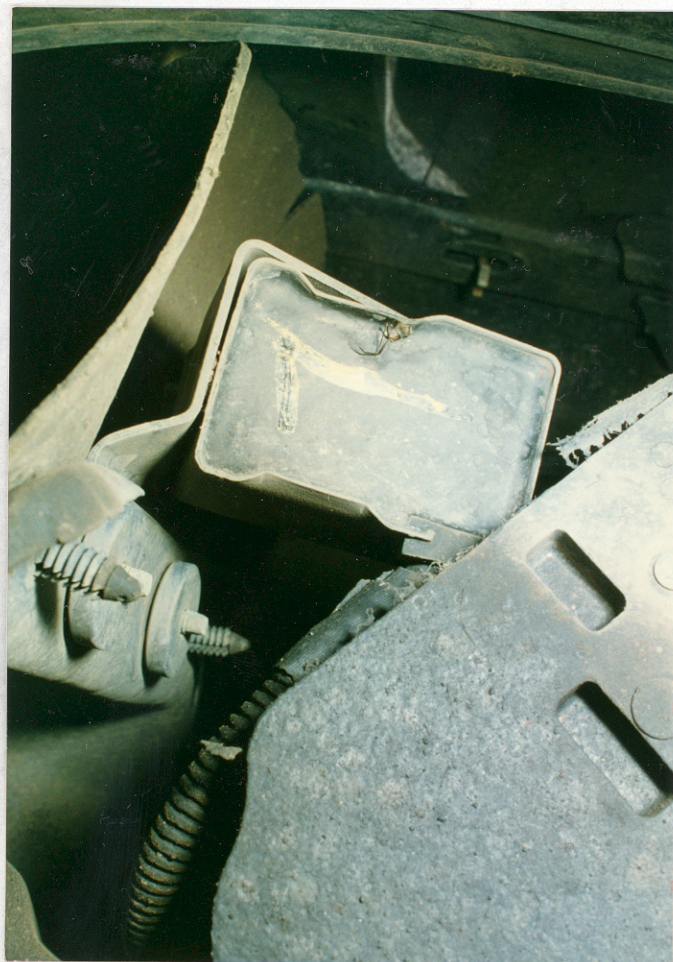
30. View of the left front crash sensor looking at the right side sensor with the front bumper located along the right side of the photograph

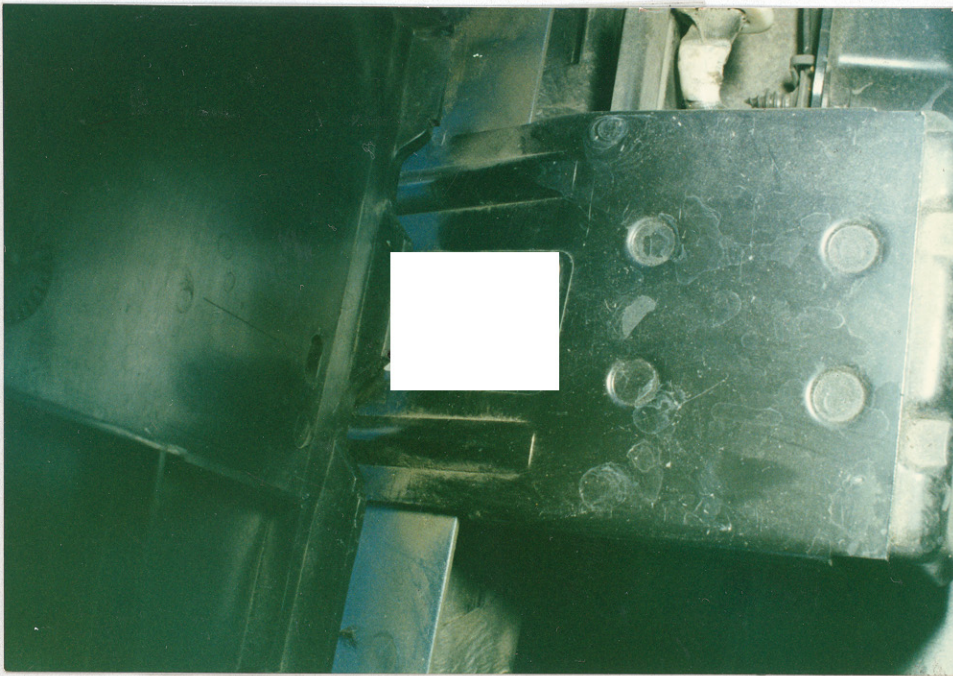
32. Overhead view of the radiator mounted air bag crash sensor

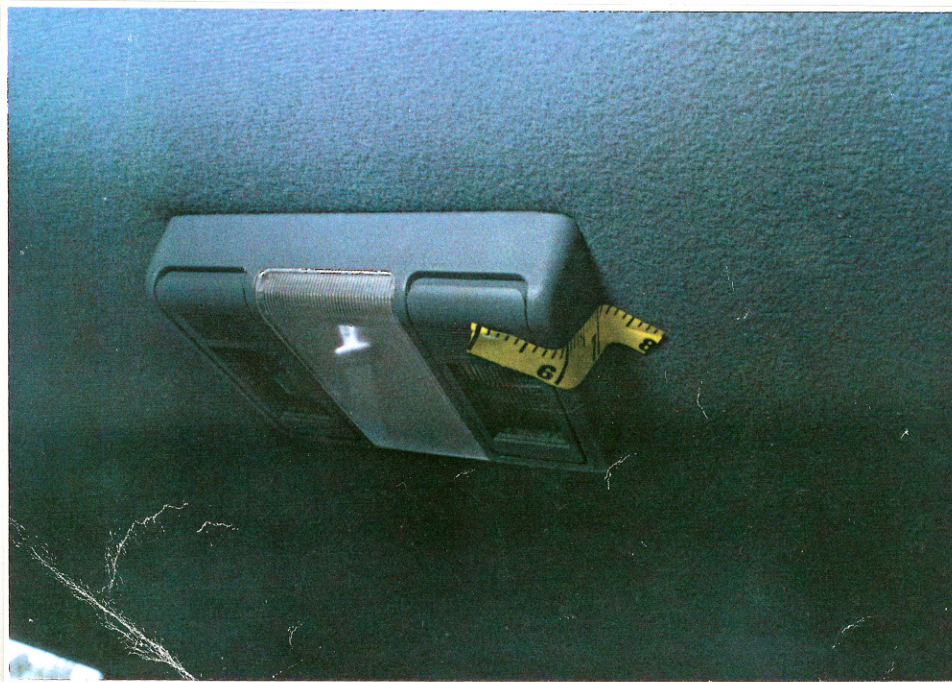
36. Close-up view of contact on the left front corner of the courtesy light bracket

Her left thigh contacted the bottom of the steering wheel rim which deflected the leg downward. The back of the left calf then contacted the seat cushion resulting in a 2 cm x 0.8 cm contusion. She subsequently contacted the left front corner of the courtesy light bracket with the left frontal head region resulting in a 3 cm (1.2") ovoid contusion. A skin transfer of 0.6 cm (0.25") was noted on the left front corner of the light. The rearward motion of the driver's torso was halted following the contact with the bracket.

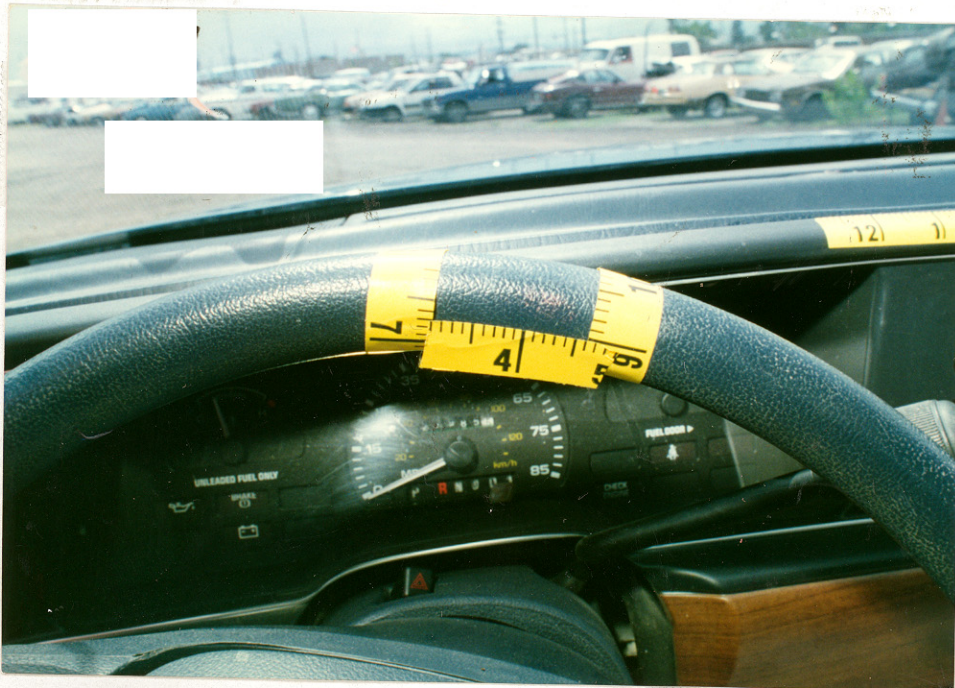
40. Close-up view of a red transfer mark on the upper steering wheel rim

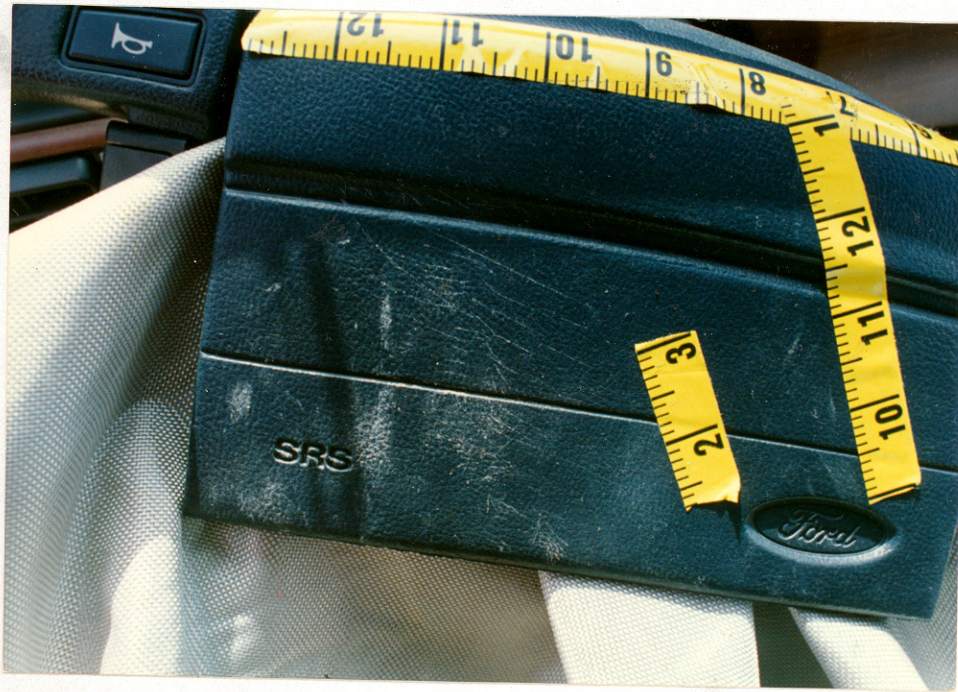
41. Close-up view of the upper flap of the air bag module cover, highlighting abrasions and skin transfers on the flap surface

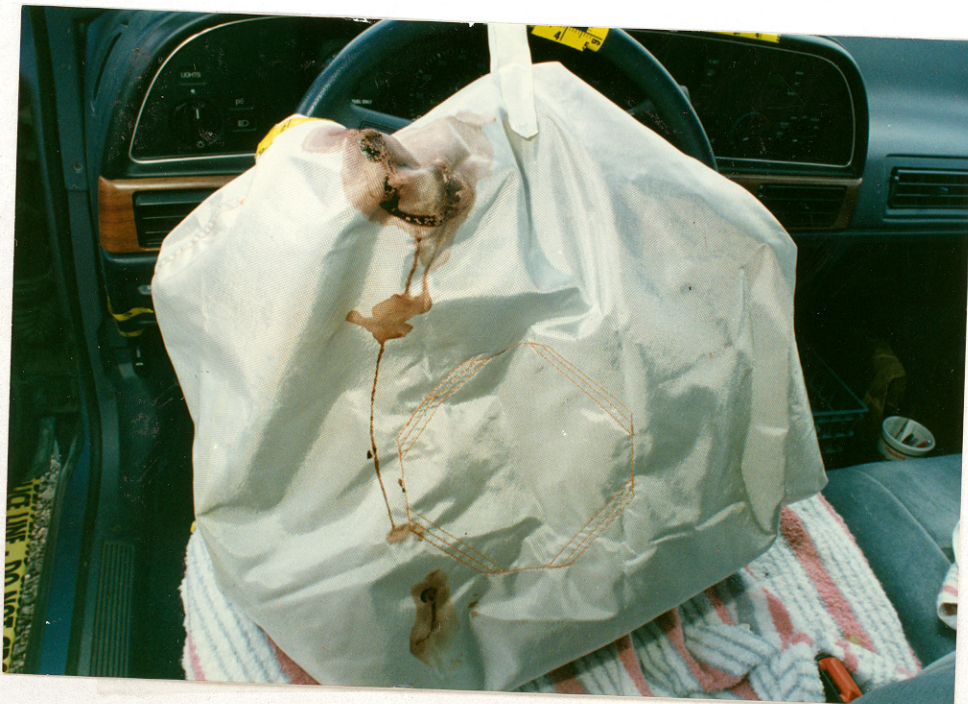
42. Overall view of the air bag showing blood stains

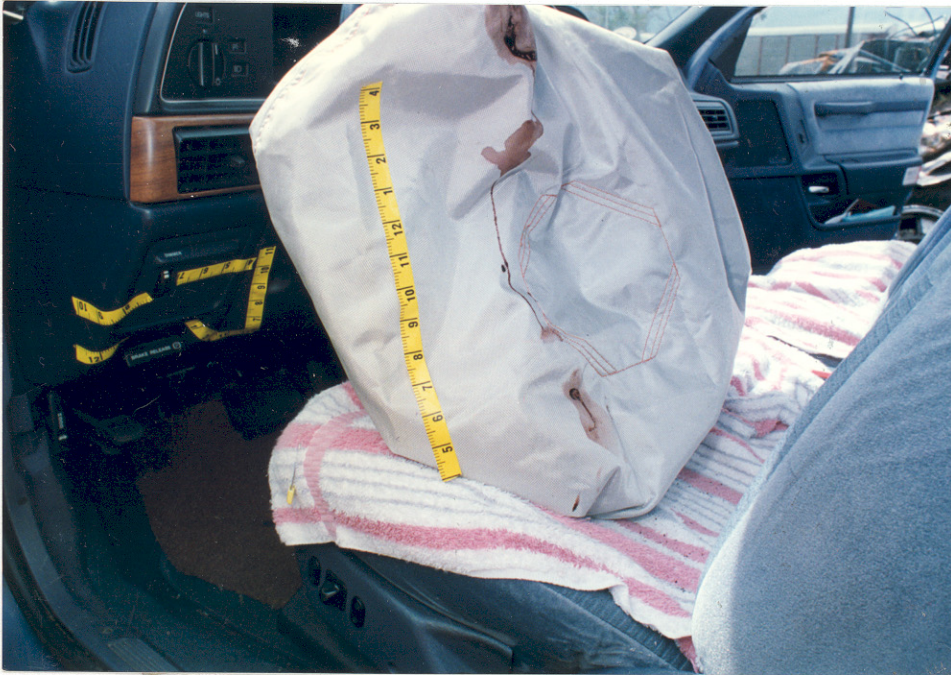
43. Angular view of the air bag and contact along the lower instrument panel

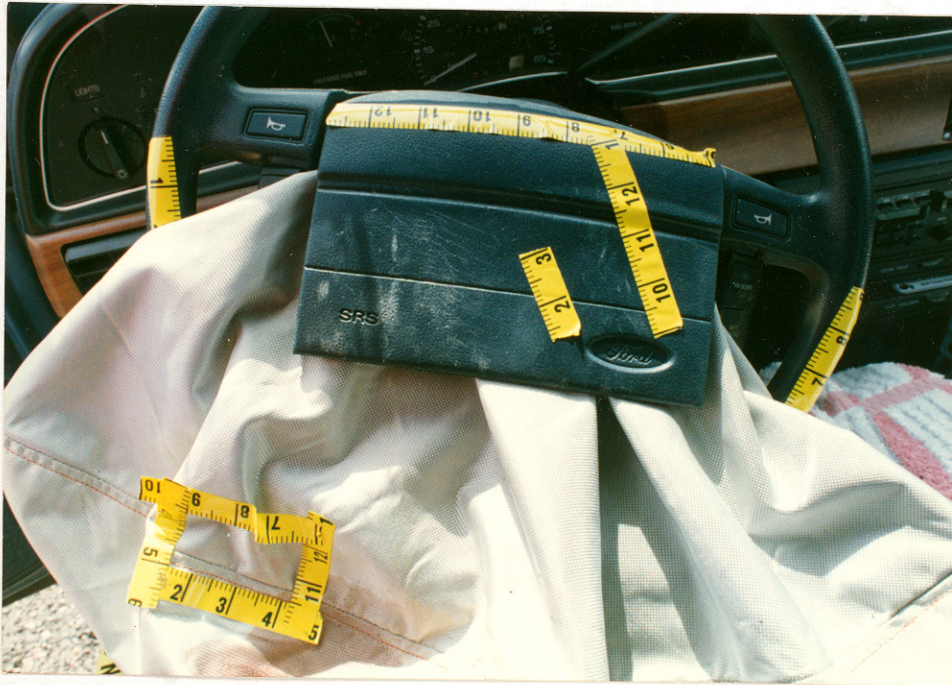
45. View of the air bag and upper flap of the air bag module cover with a red transfer (lipstick) mark on the air bag located on the instrument panel side of the peripheral seam line

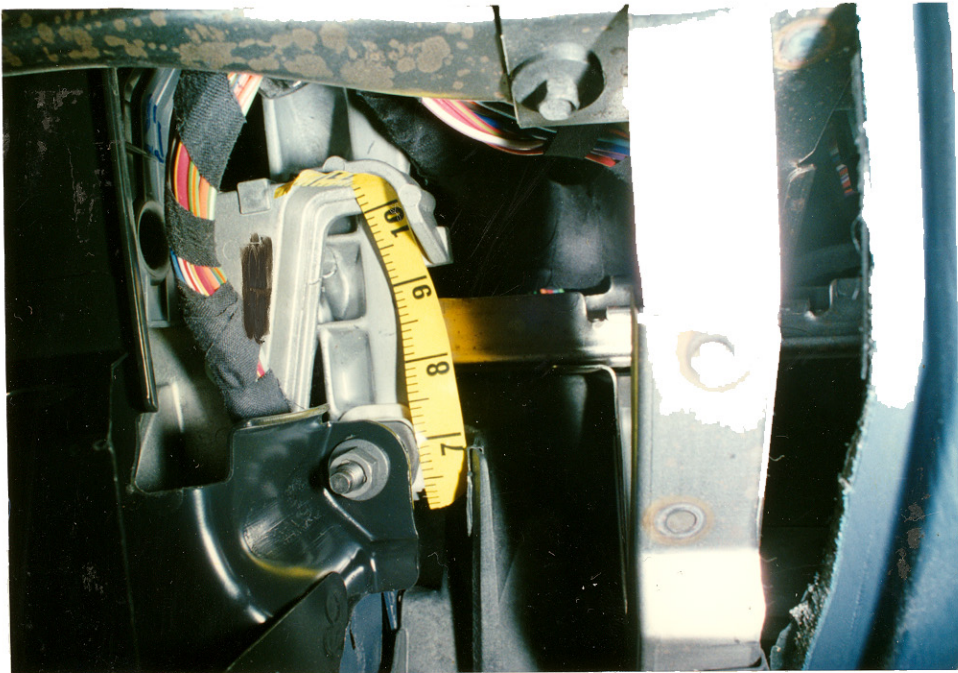
52. View showing the displacement of the left shear capsule

Interior damage was associated with contacts by the driver during the crash event. The steering column was displaced forward with movement of 7.0 cm (2.75") at the left shear capsule and 6.4 cm (2.5") at the right shear capsule. This displacement was the result of direct contact by the driver's thoracic area on the air bag module cover during the air bag deployment sequence. The upper half of the steering wheel rim was displaced forward 0.6 cm (0.25") by the air bag.

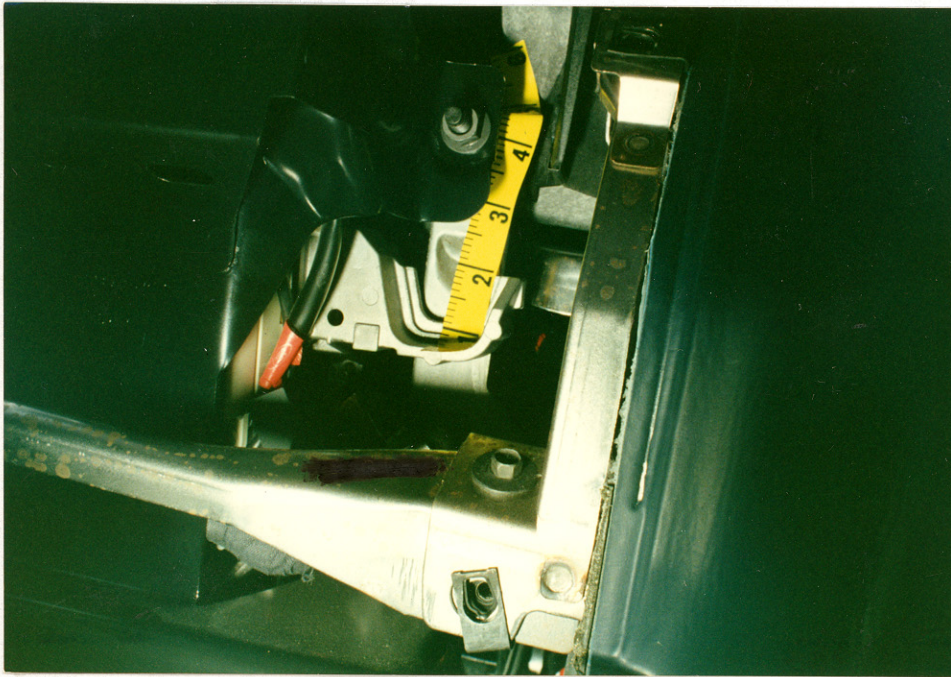
53. View showing the displacement of the right shear capsule

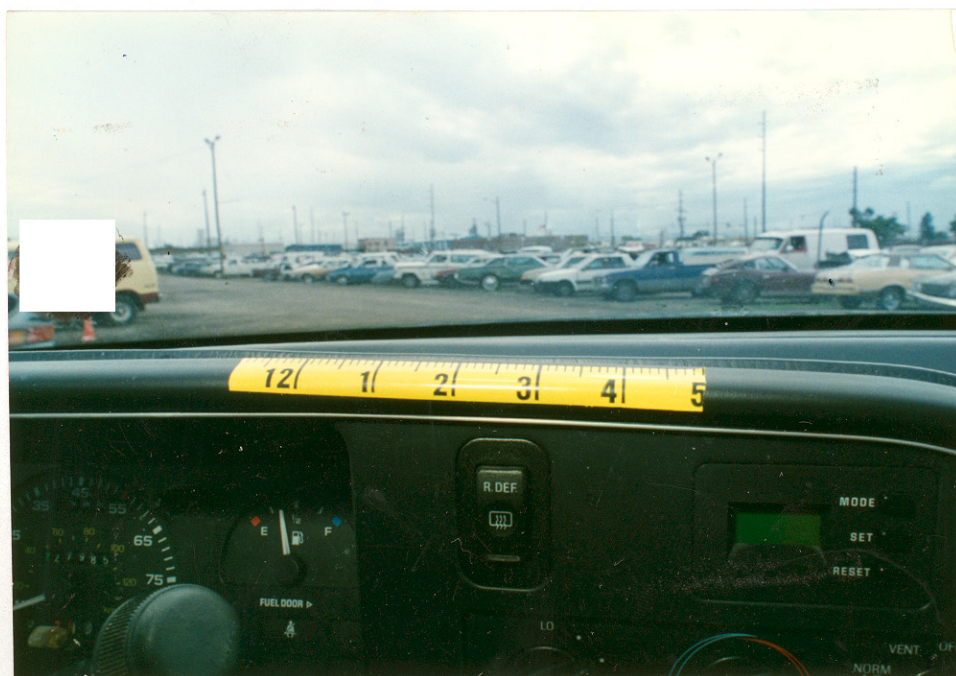
58. Close-up view of driver contact along the upper edge of the instrument panel showing an indentation of the vinyl surface

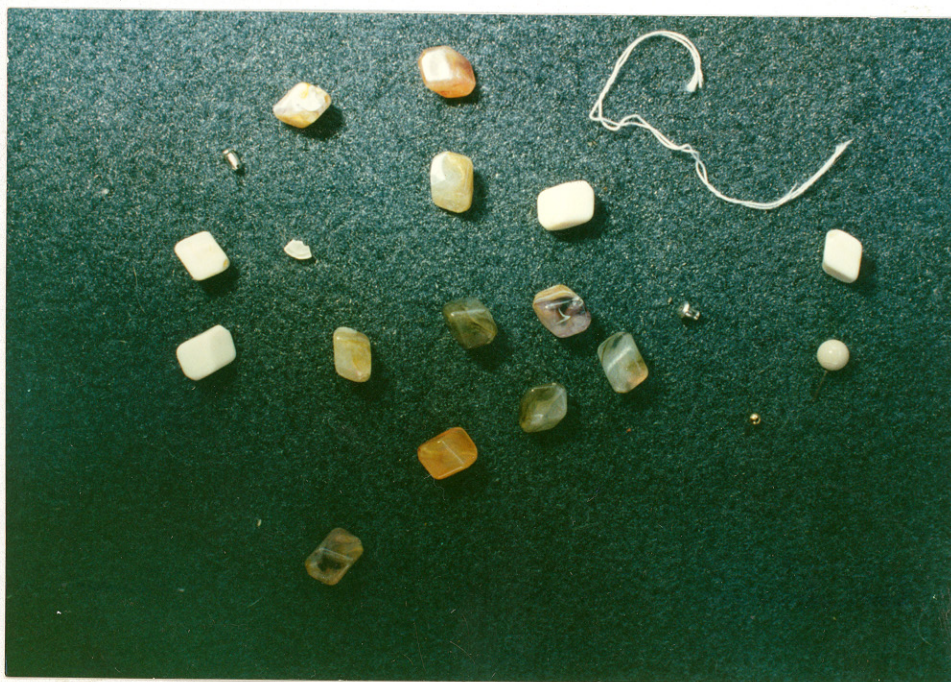
64. Close-up view of the driver's gemstone necklace

Several police personnel responded to the crash scene, in-part, due to the type of head and neck injury reported by [REDACTED] personnel to the Ford driver which was described as a gunshot wound type injury. The hospital subsequently ruled out this preliminary finding through x-ray tests. This injury was caused by the interaction between the upper flap of the air bag module cover and the driver's gemstone necklace during the air bag deployment sequence.

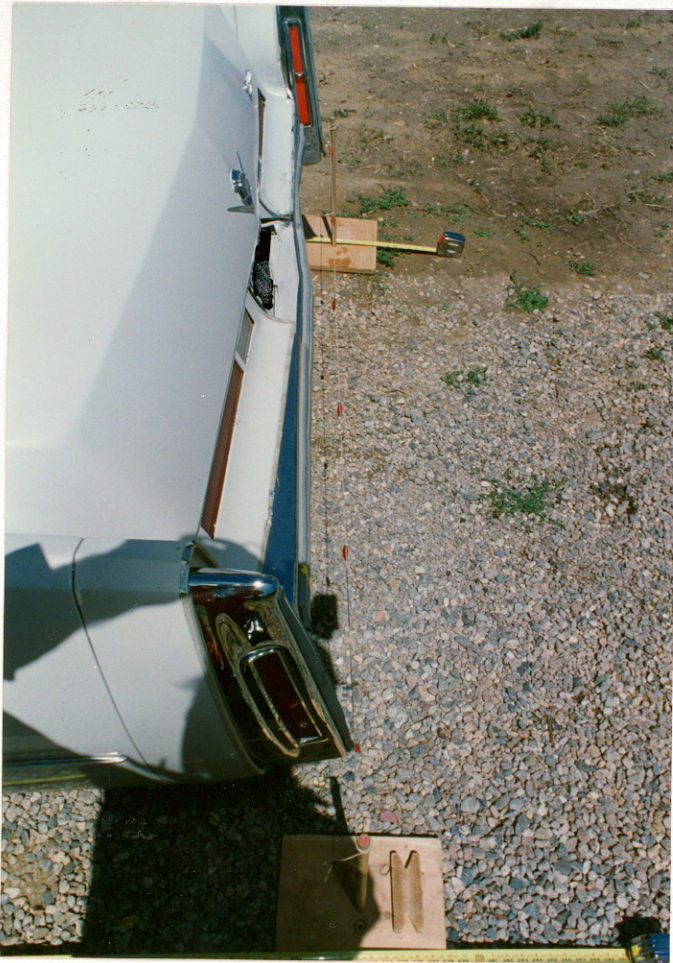
69. Overhead view  
from the left side of the  
rear plane illustrating  
bumper displacement

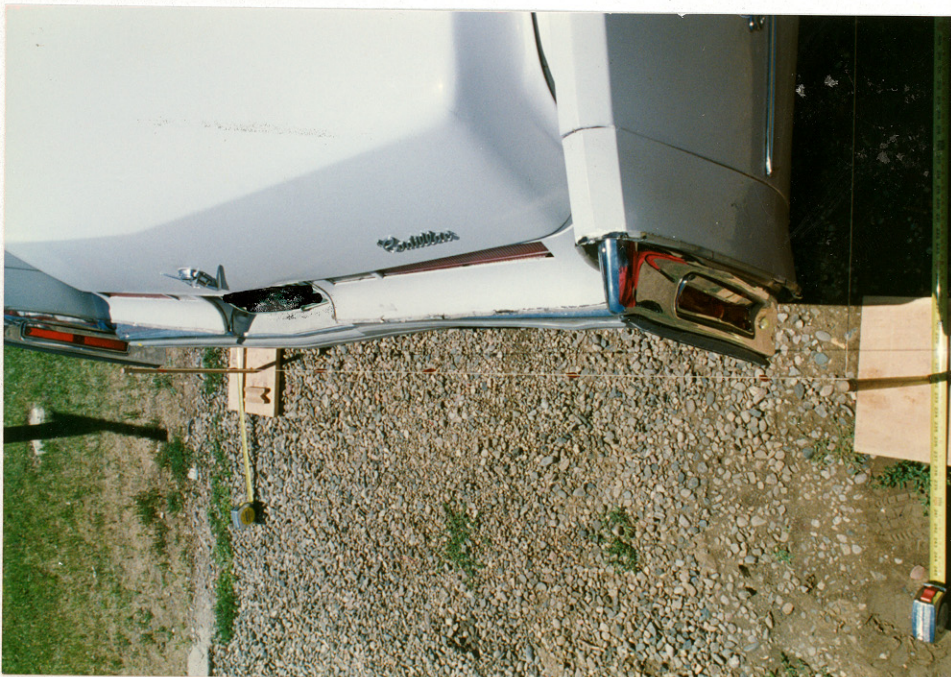
72. Overhead view from the right side of the rear plane showing bumper displacement
